Tippecanoe Lake Storm Drain Project

An Engineering Feasibility Study
Prepared for:

Final Draft
March 2006

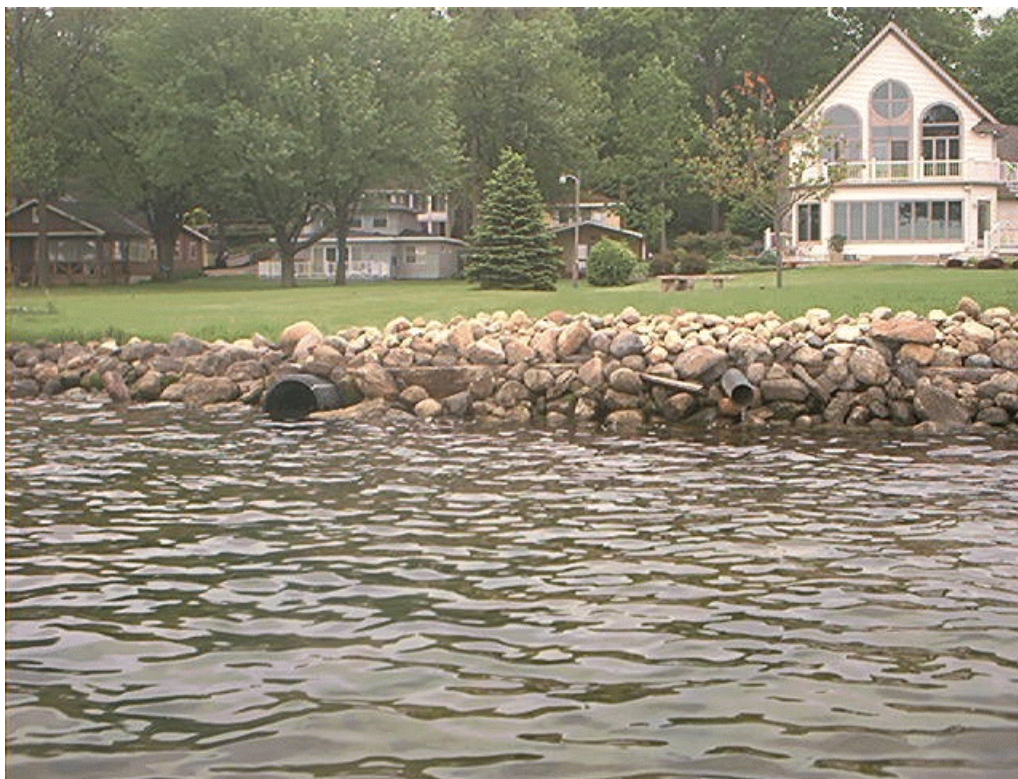
Fig. 4. Examples of storm water inlet pipes

There were 39 storm water inlet pipes like the ones shown in Fig. 4 identified in the study. Locations of the inlet pipes are shown in Fig. 5.

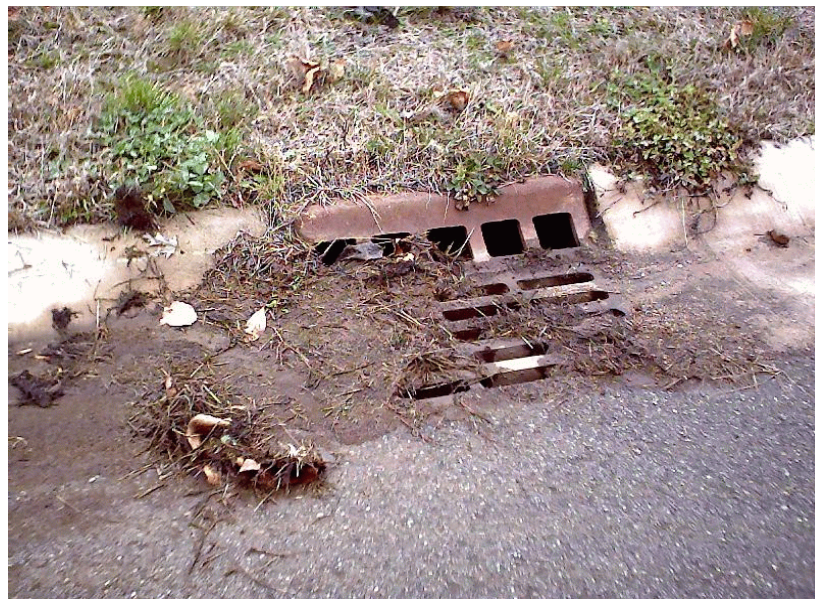
Fig. 6. A typical street drain with an inlet to Tippecanoe Lake

During the survey, 40 street drains like the one shown in Fig. 6 were identified and mapped. Generalized locations of all street drains are shown in Fig. 7 and identified by latitude and longitude in Table 2. They are also shown in maps in Appendix D.

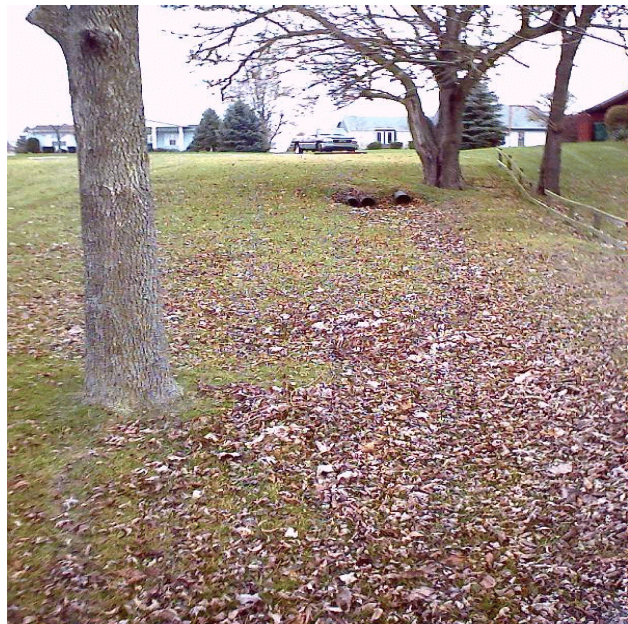
Fig. 8. A vegetated swale.

An example of an existing storm water treatment system installed by the developer of Lakeside Subdivision on Little Tippecanoe Lake is shown in Fig. 8. This system is a “vegetated swale” that slows down the drainage process and uses vegetation to trap sediment particles and enhance infiltration before the storm water reaches the lake. This type of system is very inexpensive (less than \$30 per linear foot to install) and easily maintained (regular mowing and removal of cuttings),

Note the three storm water pipes on the upstream end of the swale. Much of the water flowing from these pipes sinks into the ground before discharge to the lake. This has the benefit of cleaning up the storm water and re-charging the ground water.

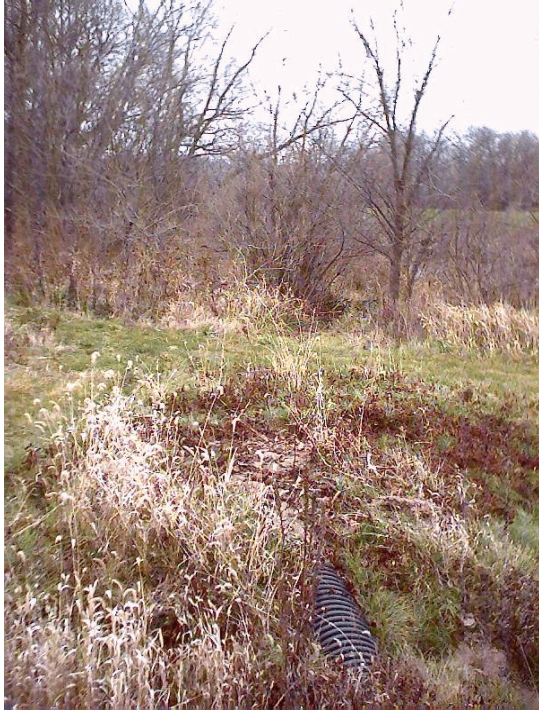
Fig. 9. Wetland storm water treatment
Sawgrass Subdivision

Another example of an existing storm water treatment system in the Sawgrass Subdivision on Little Tippecanoe Lake is shown in Fig. 9. This BMP is similar to a “vegetated swale” but uses wetland plants to treat the water prior to discharge to the lake. It is even more effective at pollutant removal than a vegetated swale because the storm water more completely infiltrates the soil and is incorporated into the tissues of vegetation before it reaches the lake.

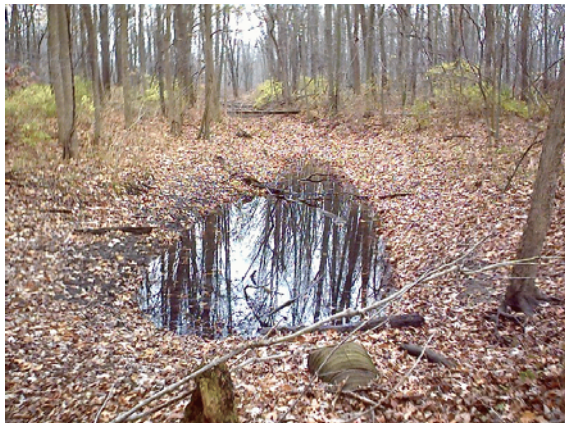
Fig. 10. Overflow from Stanton Lake
Potential wetland treatment site.

A potential site for development of a storm water treatment wetland is at the outlet of Stanton Lake along Forest Glen Avenue on the south side of the lake. This site receives storm water runoff from streets around Stanton Lake. A photo of the site is shown in Fig. 10. This site is owned by Patona Enterprises, which has expressed interest in exploring the possibility of a wetland treatment system.

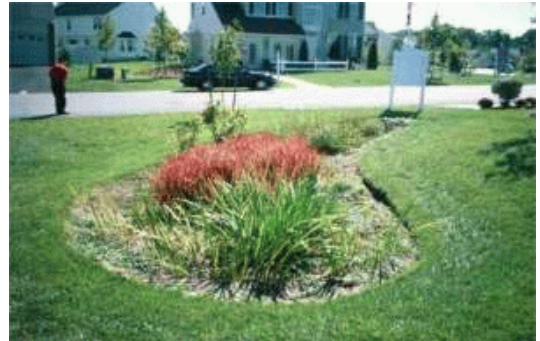
Fig. 12. A typical rain garden

Another type of Best Management Practice for street runoff is the installation of bioretention filters, also known as “rain gardens,” at strategic locations where rain water collects [7]. An example of what a typical rain garden looks like is shown in Fig. 12. A site plan showing how rain gardens may be incorporated into a property is shown in Fig. 13.

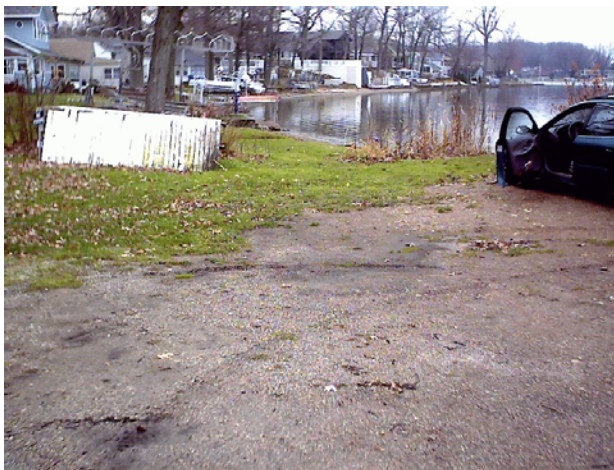
Fig. 15. Tippy Ballroom parking lot
Potential rain garden site

In addition, rain gardens would be appropriate in community-owned areas where the lake association could assist with funding and maintenance for cleanup of street runoff. Examples of sites where rain gardens would be appropriate for this use are in Bell Rohr Park and Russell Park. Another site where a rain garden would be useful is adjacent to the parking lot of the Tippy Ballroom (Fig. 14). A community rain garden that is 200 square feet in area should cost less than \$2000 to build and less than \$500 a year to maintain.

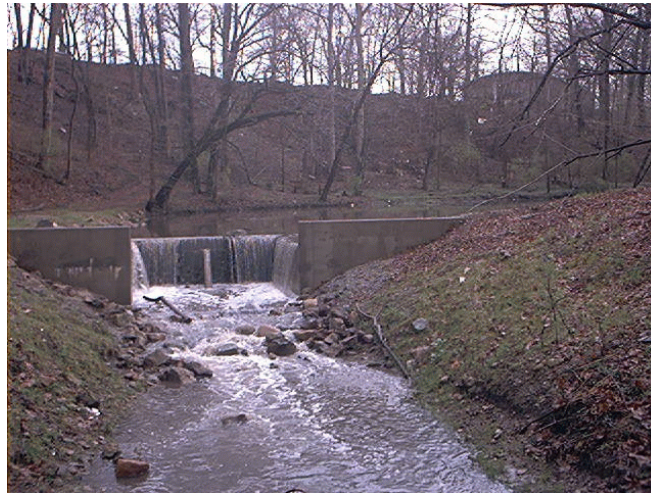
Fig. 15. Sediment basin to trap storm runoff

Another BMP that could be implemented for water quality improvement is a sediment basin to collect and treat runoff along Kalorama Road, where street runoff now flows directly into a gully and then to the lake. A sediment basin similar to the one shown in Fig. 15 would help improve water quality at this site, owned by Paton Enterprises.

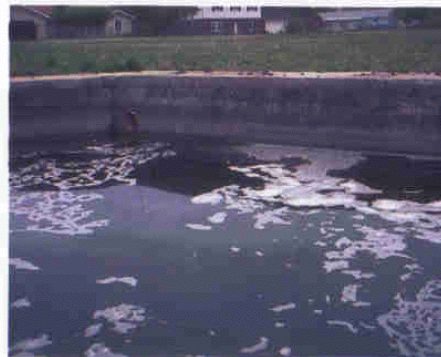
Pollutants find their way to the lake in storm water runoff.

Street runoff adds about 25 pounds of phosphorus and 150 pounds of nitrogen to the lake each year. This amount, though small compared to loading from the rest of the watershed, is one of the most easily eliminated sources of nutrients.

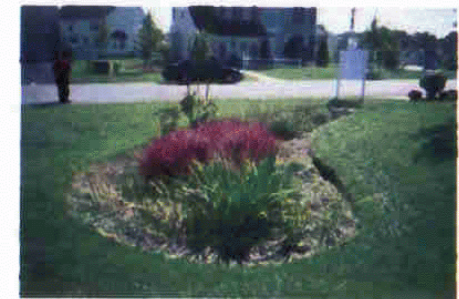
Another possibility is the installation of bioretention filters ("rain gardens") where storm water accumulates along

roads. These are relatively inexpensive and add to a beautiful landscape.
